Inspection Report

for Ministry of Education, Republic of Maldives

Condition Assessment Report for Hulhumale Preschool

Company Project ID no. 20011

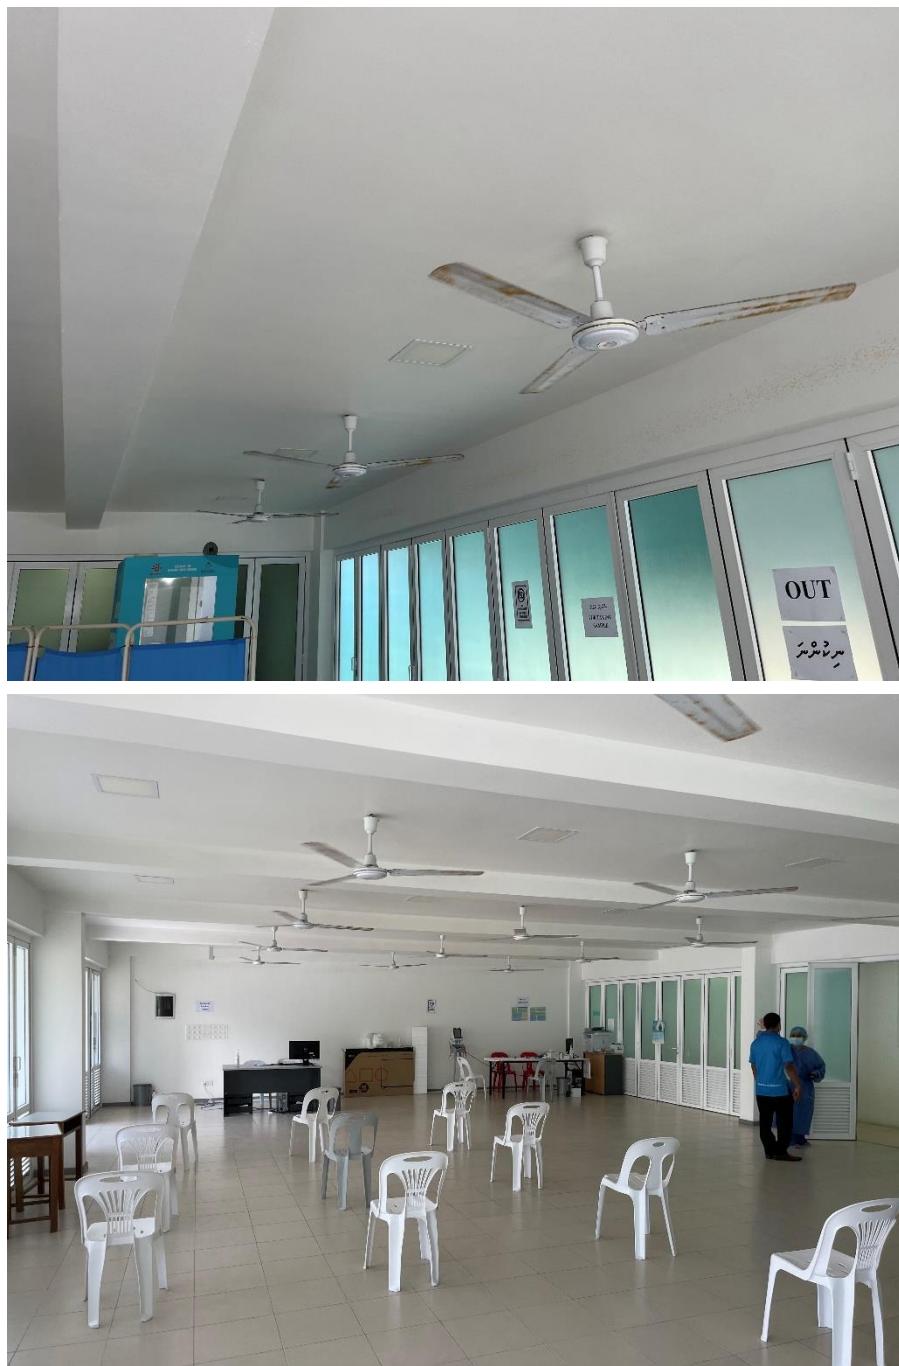
Figure 3: All fans were observed to be significantly rusted and in poor condition.

- Replace all the fans in the building with new 52-54" fans of brand approved by the Ministry and their consultants.
- Replace any damaged switches and sockets with new ones of a brand approved by the Ministry and their consultants.

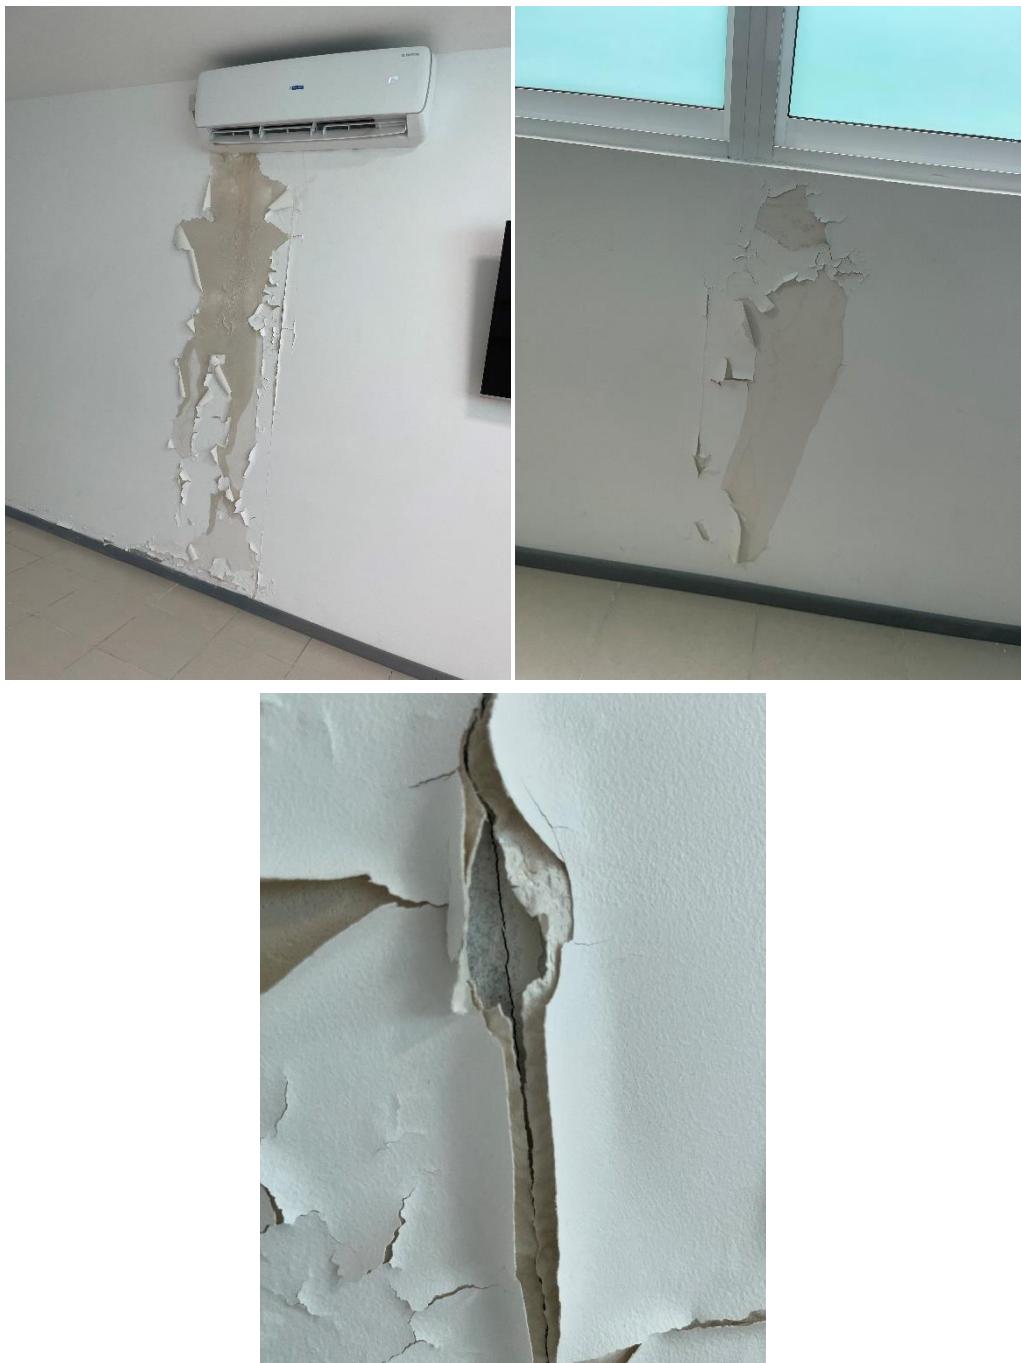
Figure 4: Water Damage and crack in Walls

With the extent of available information, i.e. where details of the actual masonry construction methodology are unknown, it is felt that the cracks at masonry joints are due to building movement, and inadequate provision of bonding material at the joints. While the defects affect the serviceability of the building and are severe in some cases, it does not affect the structural integrity of the building. Most of these are live cracks and will continue to propagate if not addressed adequately and in a timely manner.

The water damage was observed to be located mostly within the edge walls near the windows and/or where air-conditioning was installed on walls. Therefore, it may be due to cracks in the walls, or due to improperly sealed AC ducts within the walls. The water ingress may also be due to poor workmanship in installation of the windows, resulting in water seepage through spaces that have not been sealed properly. Hence, these cracks and leaks needs to be fixed before repainting the walls.

- Chipping the defect to the full depth of the crack in a V-shaped groove.
- PVC chicken mesh should be placed at the joints. The surface of the concrete should be prepared prior to placement of chicken mesh through roughening up the surface by chipping.
- Filling in the chipped surface with a plaster composed of a mortar using a flexible mortar improver/repair mortar such as Sika Latex or equivalent.

CEMGUARD PC 400 or an equivalent cementitious waterproof coating should be applied on the surfaces before re-applying wall sealer and paint, after repairing the water leaks. The surfaces need to be thoroughly cleaned of loose particles and dust before application of the chemical. If these are applied without fully repairing the water leaks, the underlying issue will not be resolved, and water damage may reoccur in the near future.

Ensure that the source of water seepage is identified and resolved before applying the coatings and repainting. Check the windows, AC for any leaks and the walls for any crack that may cause water seepage and rectify accordingly (for cracks please follow items 6.1 and 6.2).

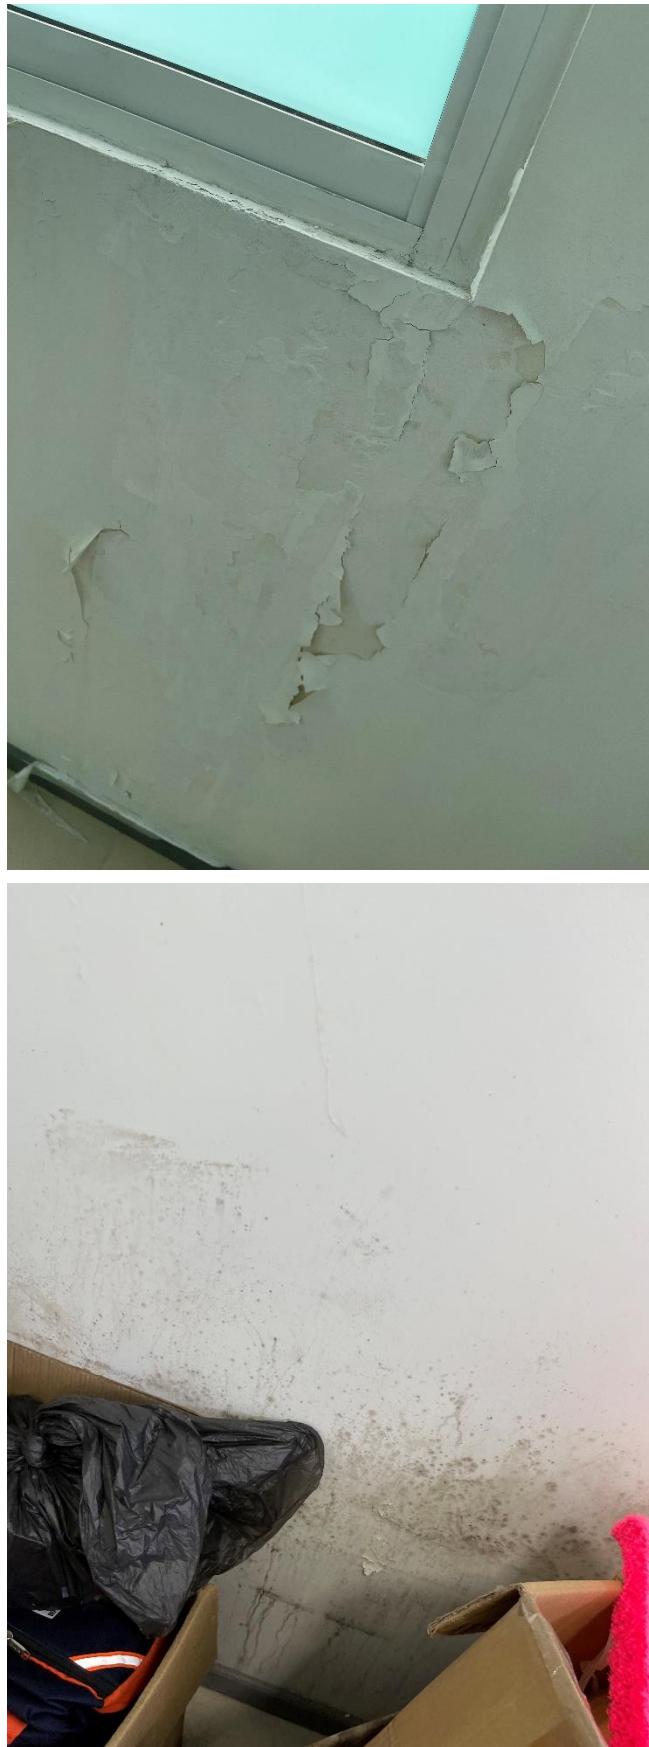
Figure 5: Water Damage and crack in walls.

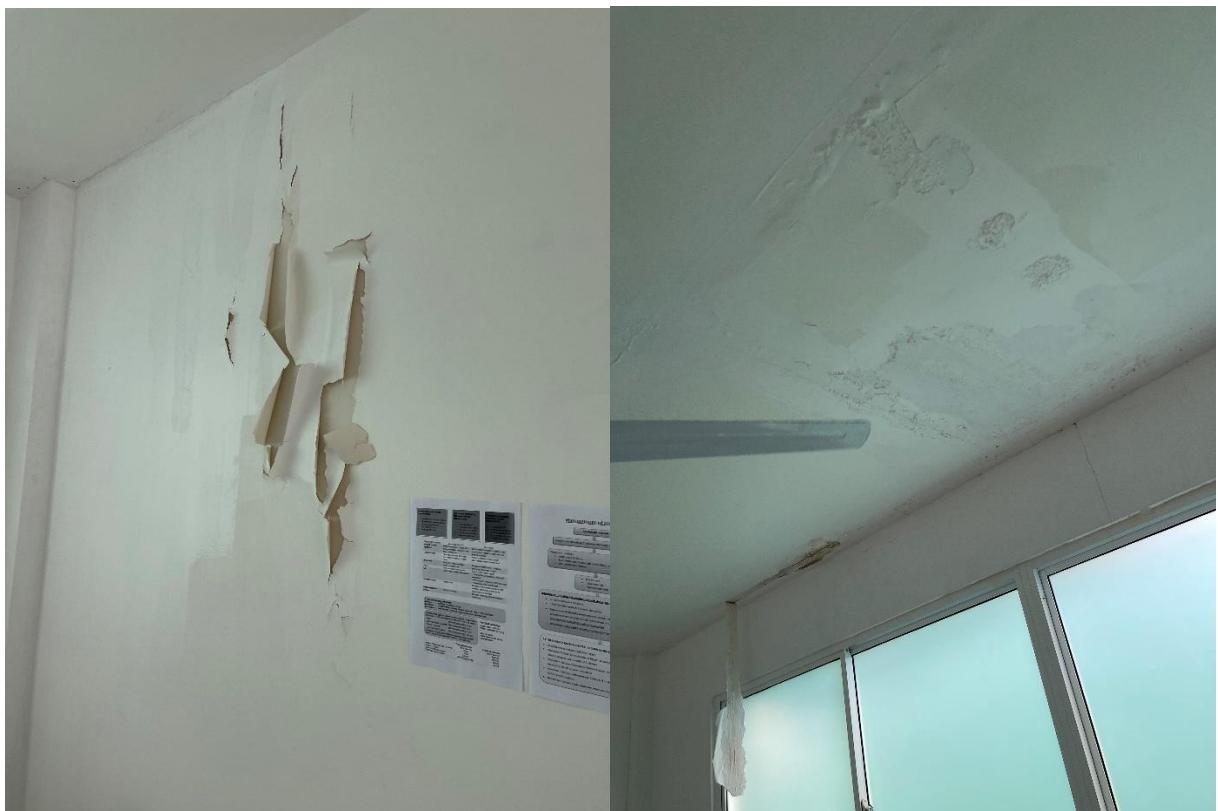
Figure 6: Water Damage.

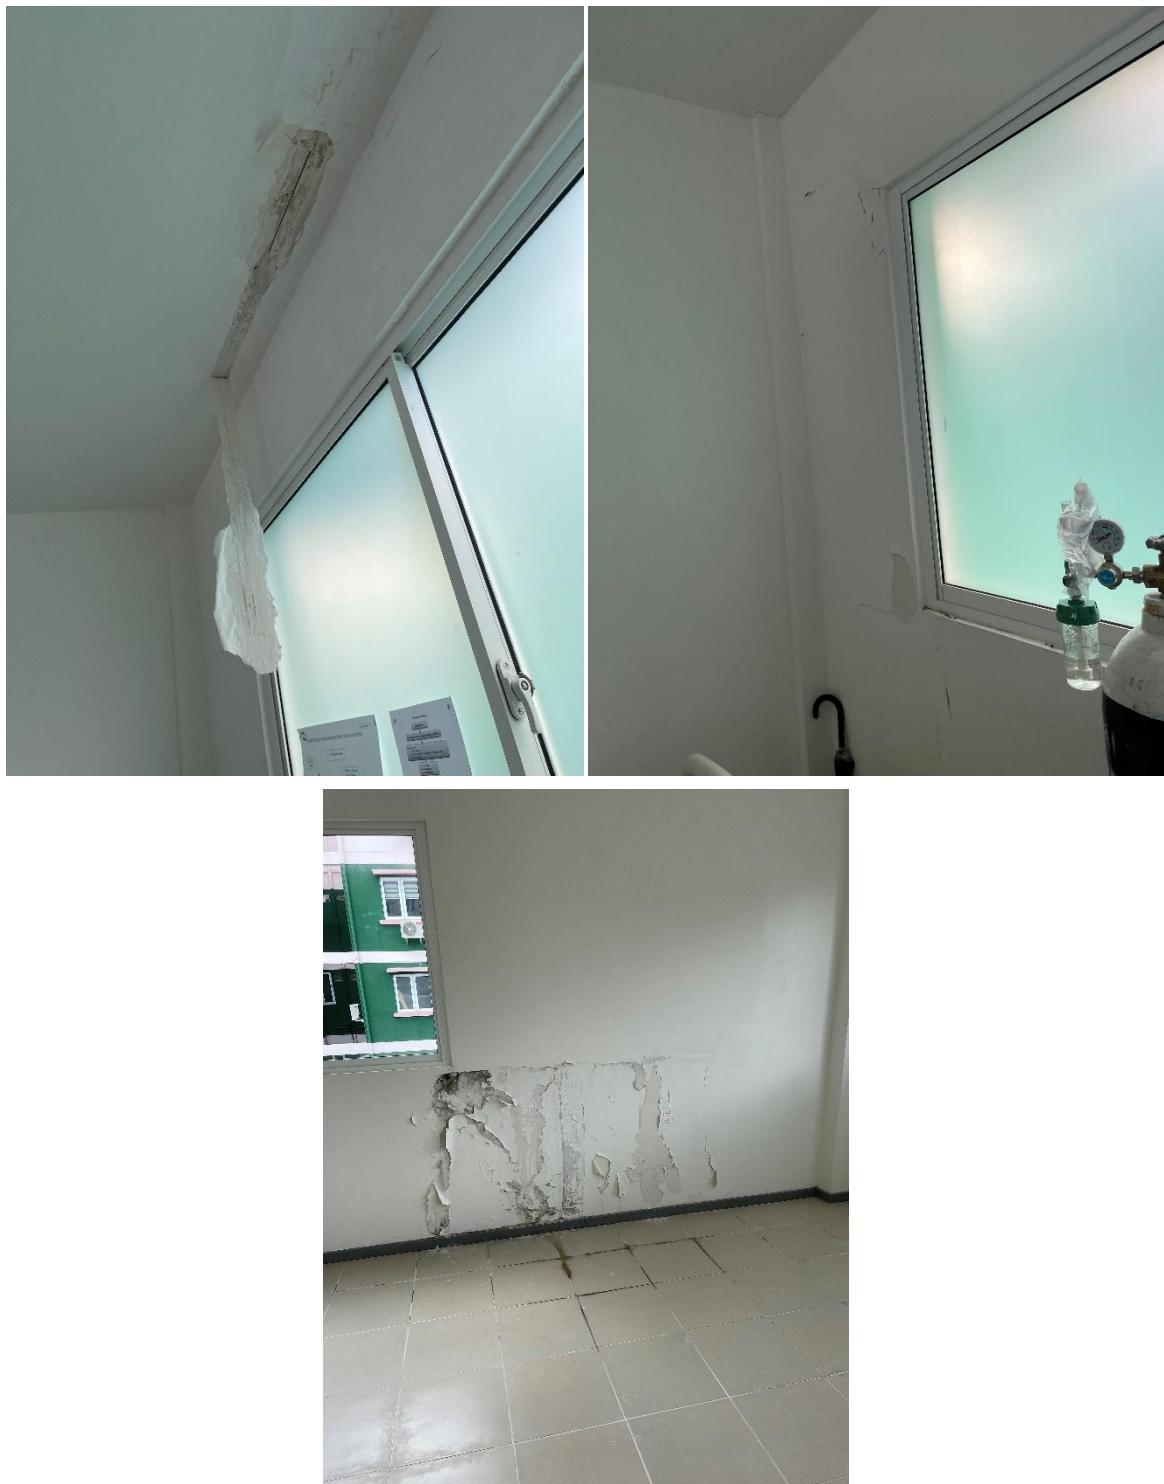
Figure 7: Water Damage Areas.

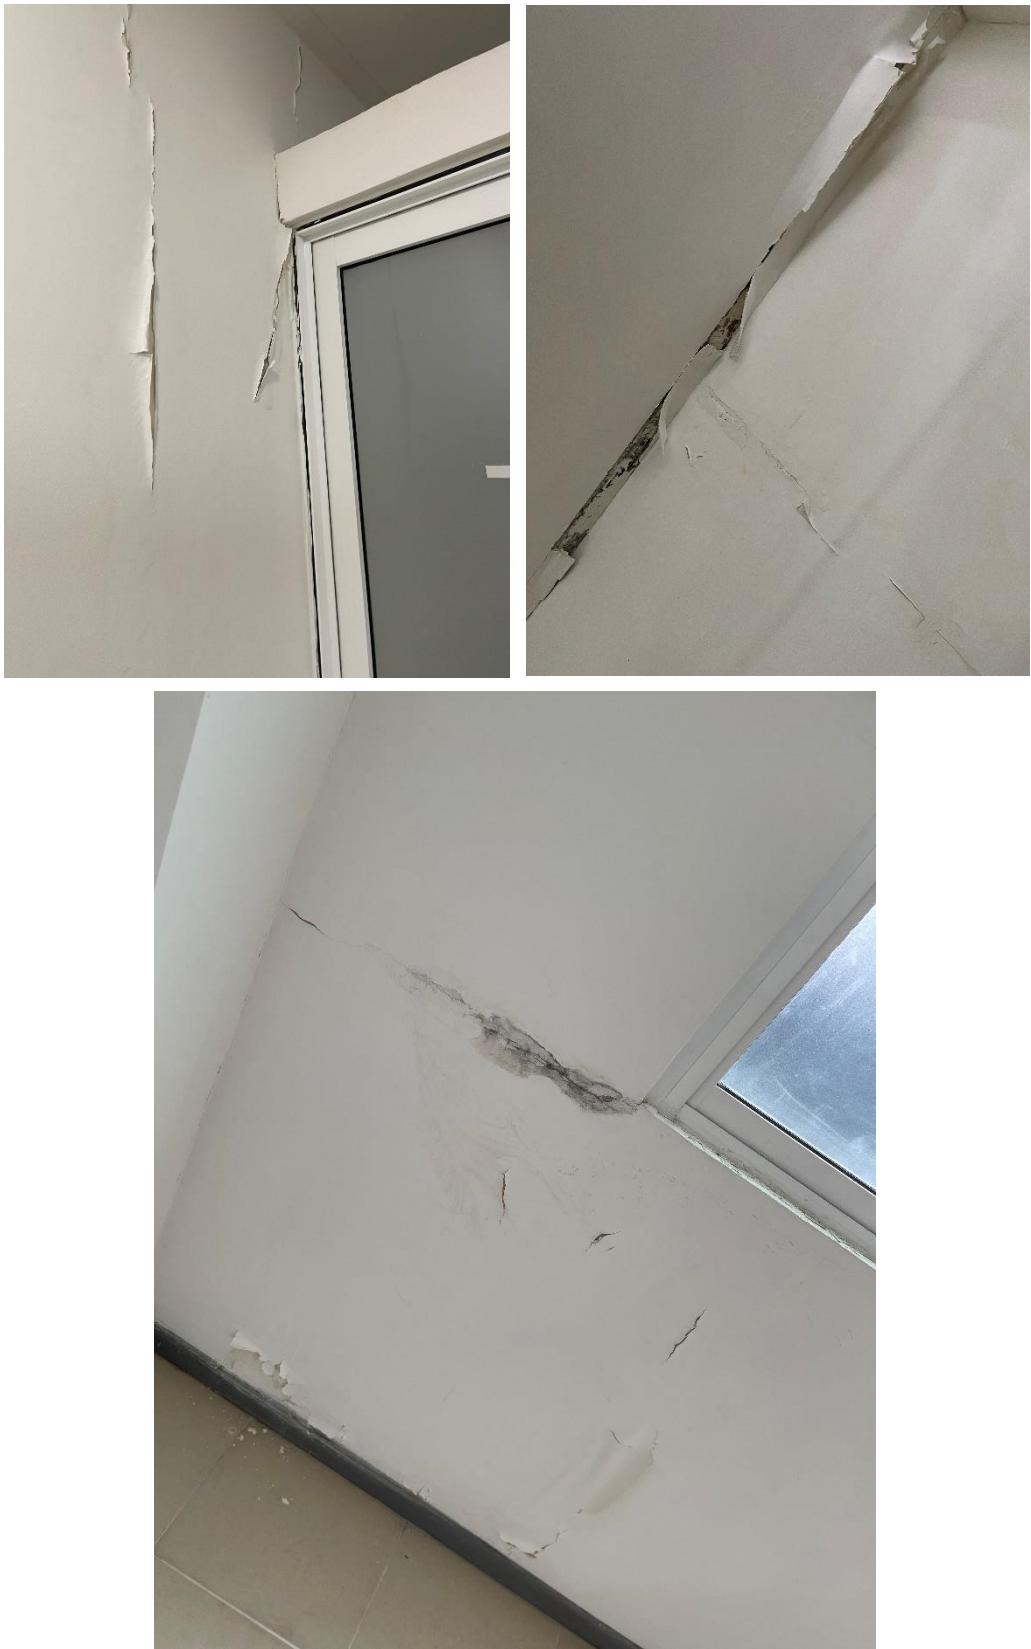
Figure 8 Water damaged areas.

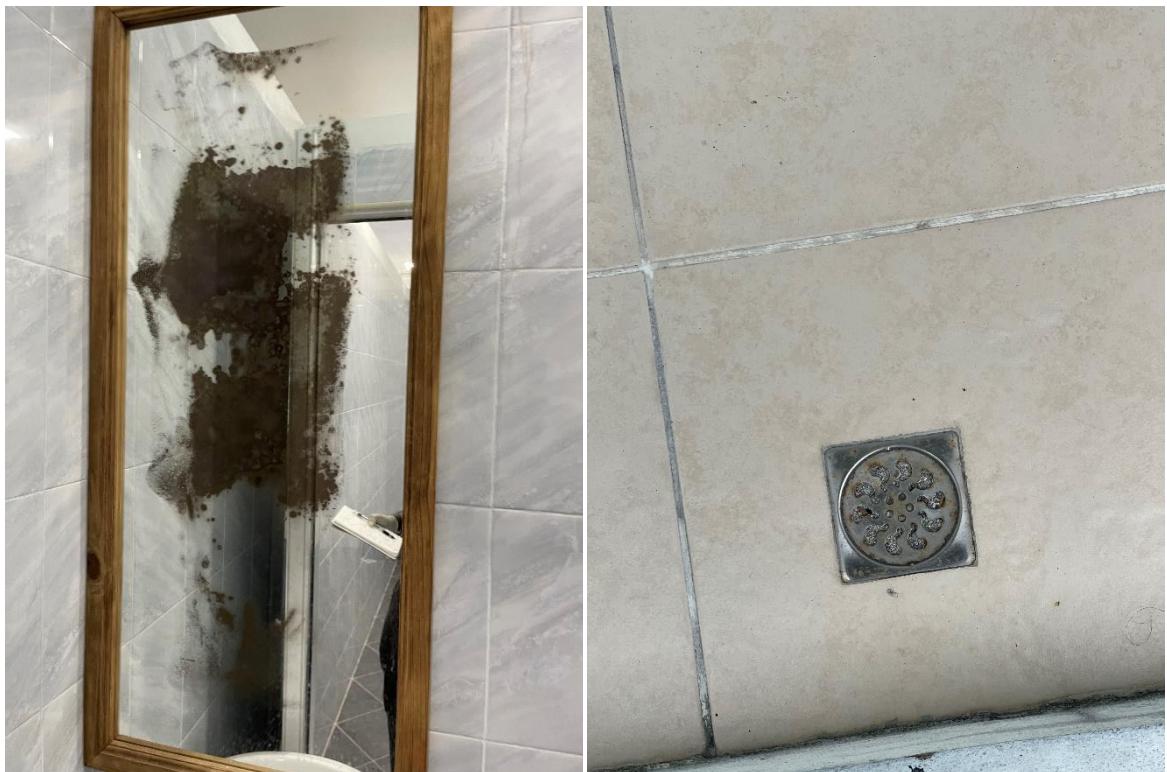
Figure 9: Toilet mirror damaged and compound drain blocked.

Some of the fixtures in the toilets appear to be damaged, therefore, as per Client's recommendation all toilet fixtures, mirrors and drain covers need to be replaced. Furthermore, the drains of the compound area in front of the toilets appear to be blocked with sand (refer to figure 09), therefore these needs to be cleared or replaced based on extent of damage to restore proper drainage.

- Replace all toilet fixtures, mirrors and drain covers, and any damaged door locks and handles.
- Clear of sand or Replace (based on extent of damage) the compound drains.

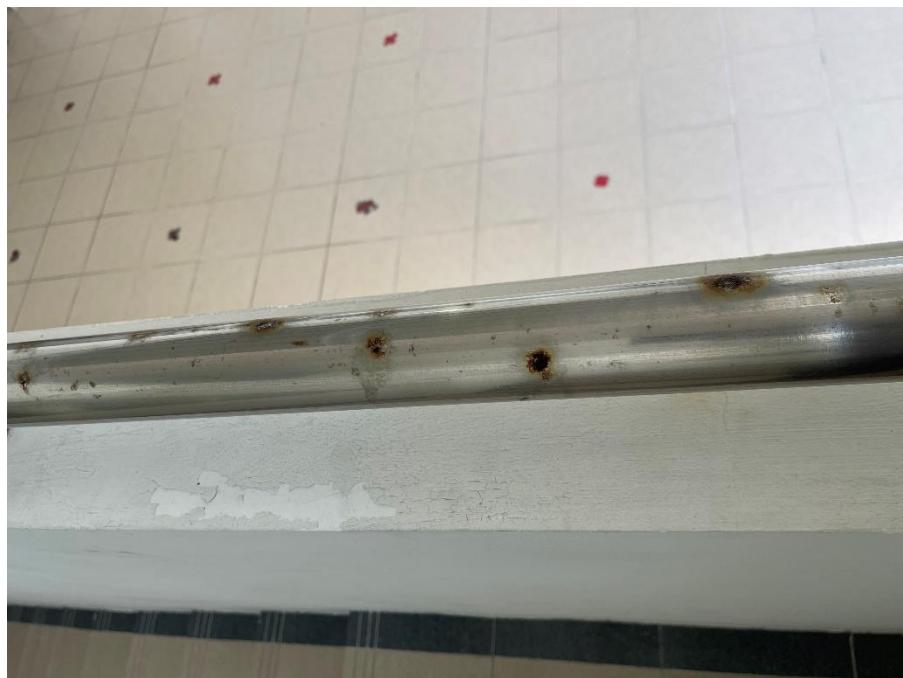
Figure 10: Rust on stair railings.

- Installation of computer network for the entire building as per client's requirement (drawings to be provided separately).
- Replace the damaged railing of the staircase.

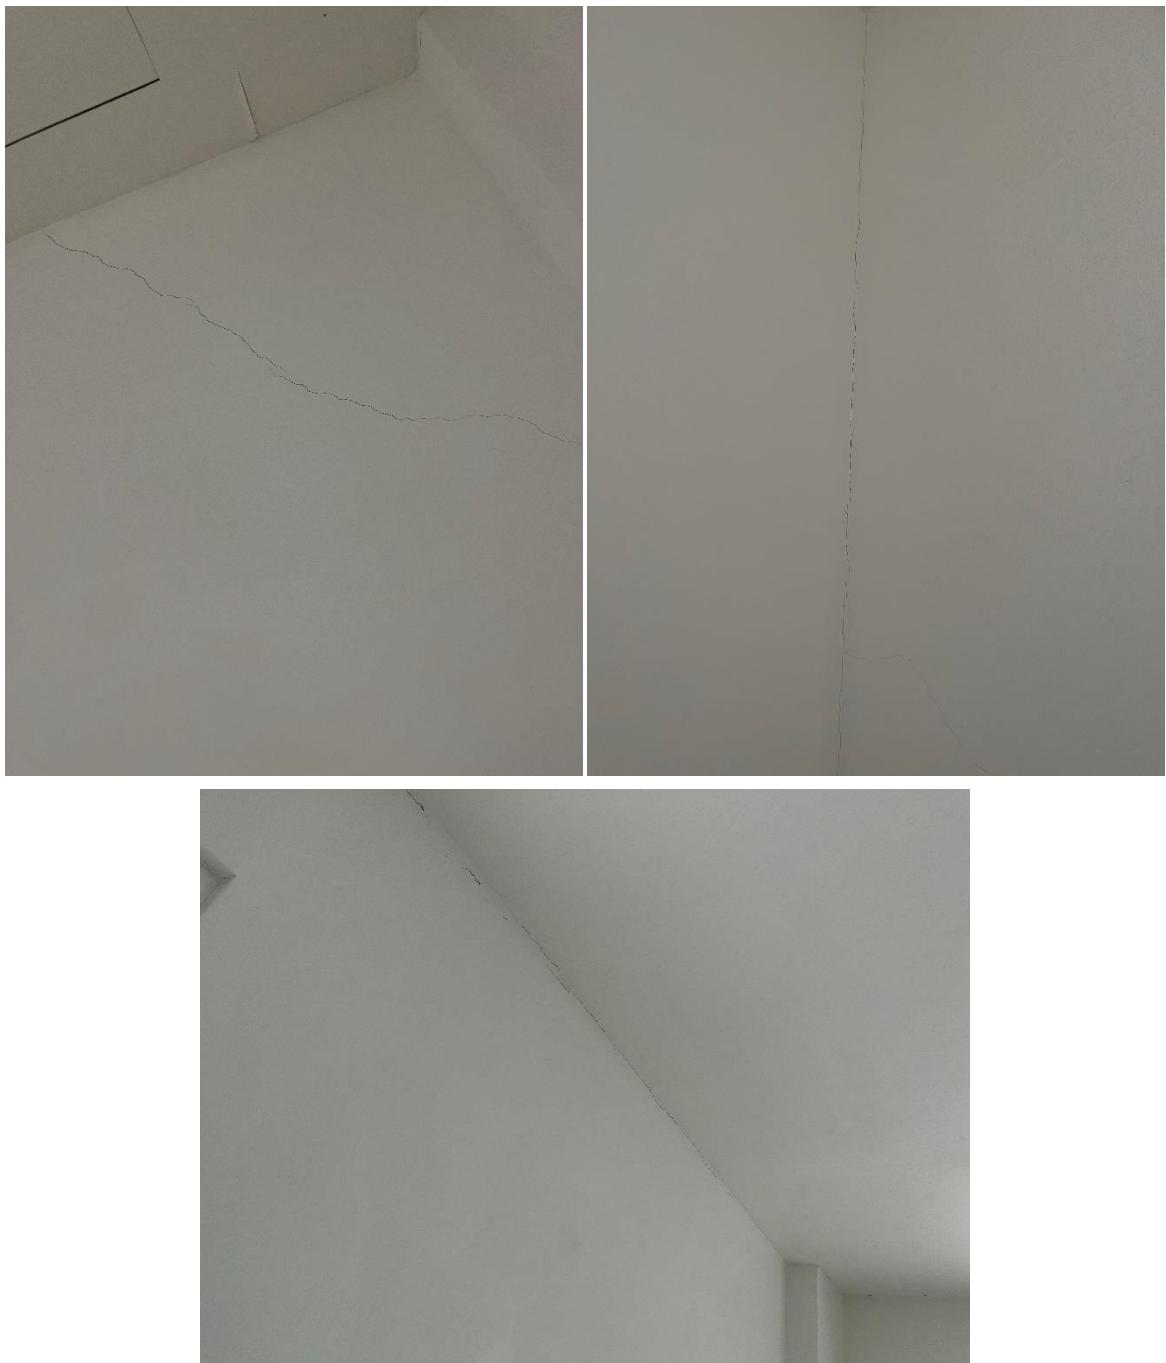
Figure 11: Wall cracks.

For isolated cracks in masonry, the above methodology may be used without placement of chicken mesh.

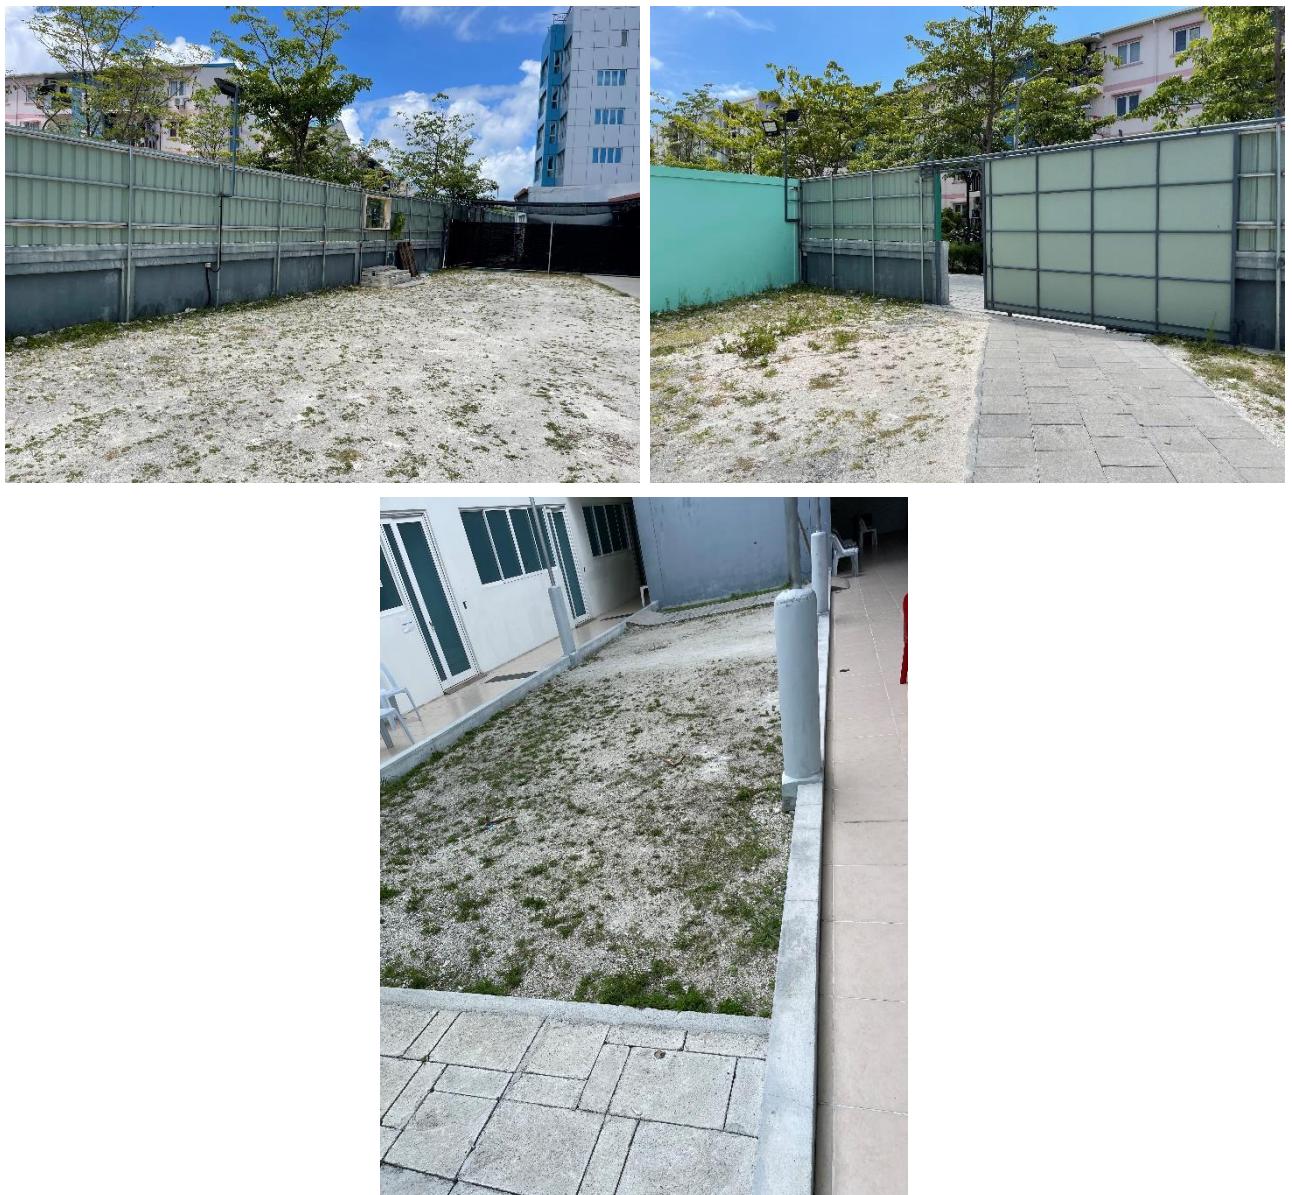
Figure 12: Front and Back compound.

- Clean and clear the entire compound area around the building and fill with thoroughly washed and dried local white sand (up to a depth of 100mm or walkway height).

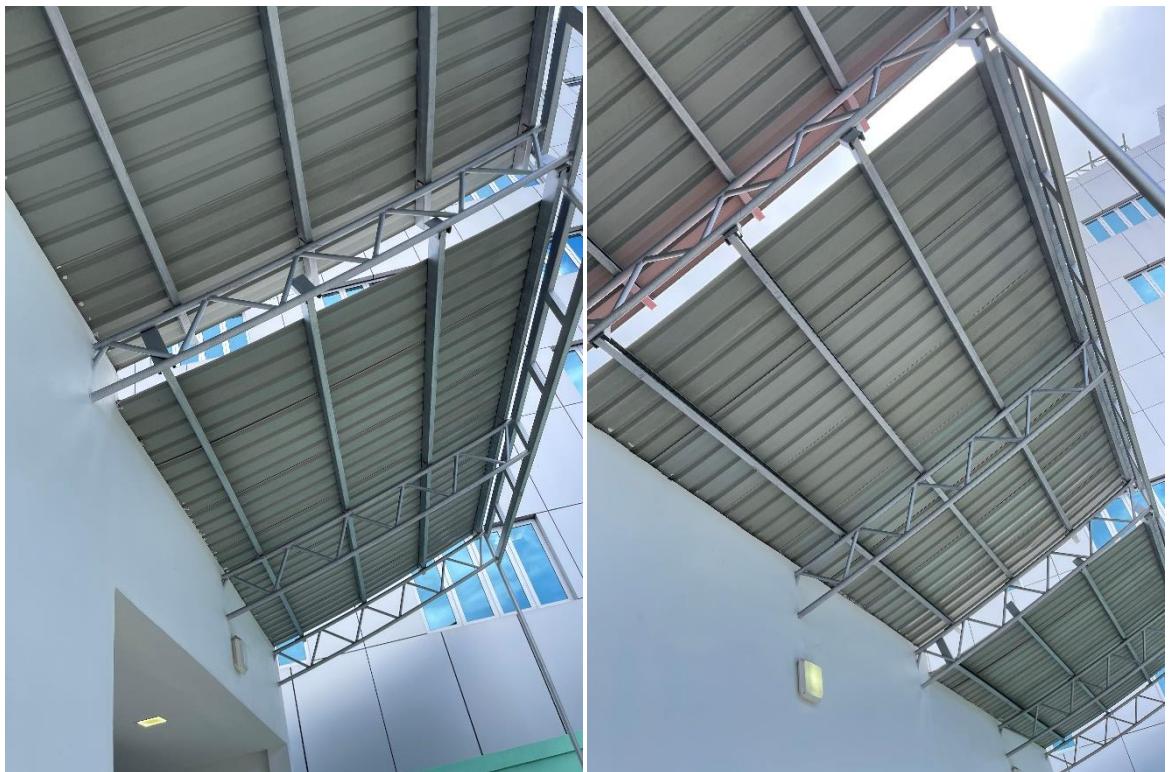
Figure 13: Spaces between the roofs.

- Replace the exhaust in the pantry.
- Install flashings between the spaces between roofs (figure 13).
- Install a shading net over the 2 main compound areas and play area.

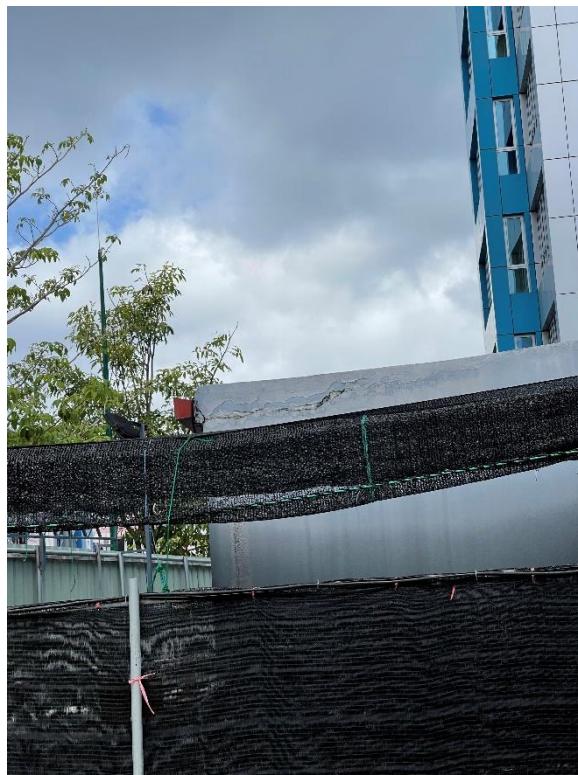
Figure 14: Crack damage at building entrance corner

- Plaster should be chipped off until completely sound plaster is reached or until the surface of concrete has been reached
- Concrete surface should be chipped mildly/roughened so as to provide a suitable surface for plastering
- A PVC chicken mesh should be placed at the joints between concrete and masonry
- Plaster should be applied with a bonding agent such as Sika Latex or equivalent
